**Subject: Jones Library, 43 Amity Street, Amherst, MA
Massachusetts Historic Rehabilitation Tax Credit Application**

Massachusetts Historic Rehabilitation
Tax Credit Application, Parts 1 & 2

Jones Library

43 Amity Street, Amherst

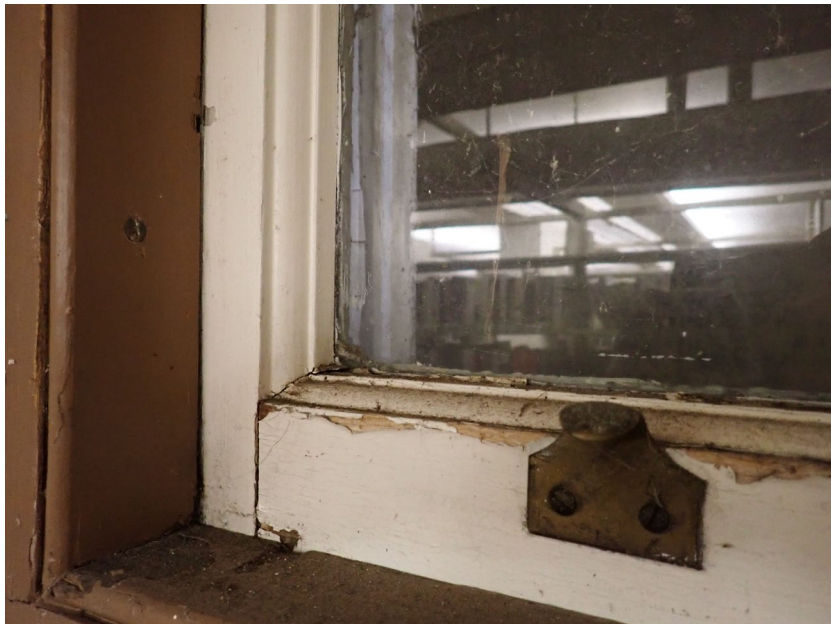
11. Basement level, south wall, detail of typical historic wood window deterioration

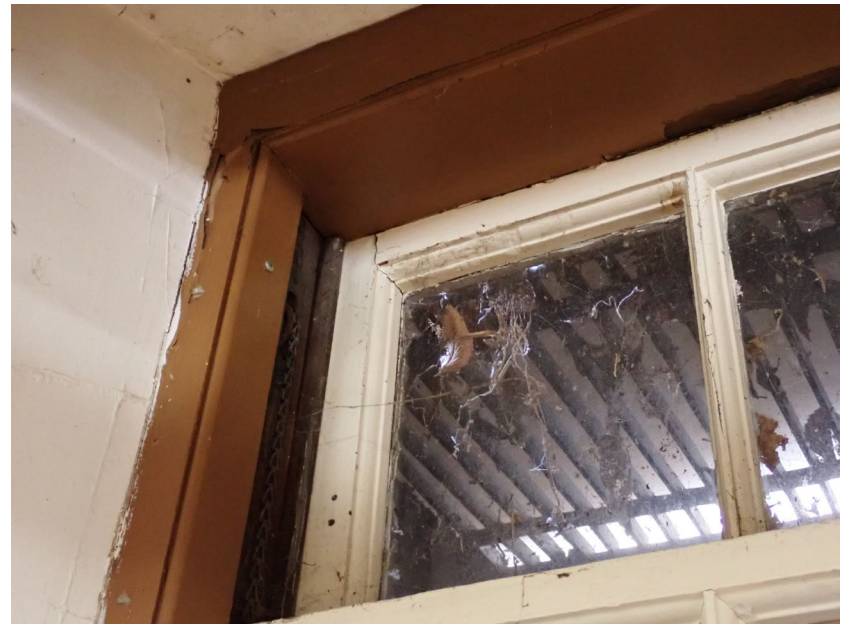
12. Basement level, south wall, detail of typical historic wood window deterioration

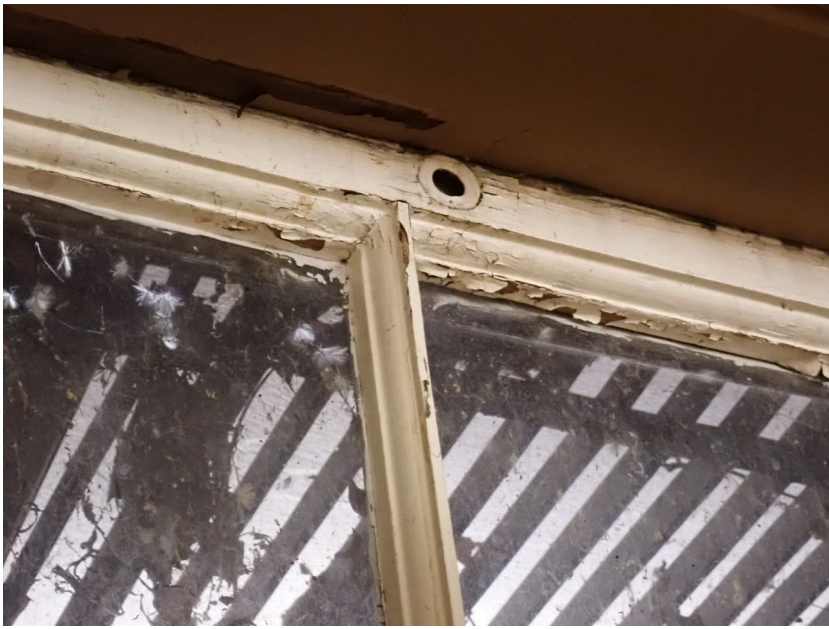
13. Basement level, south wall, detail of typical historic wood window deterioration

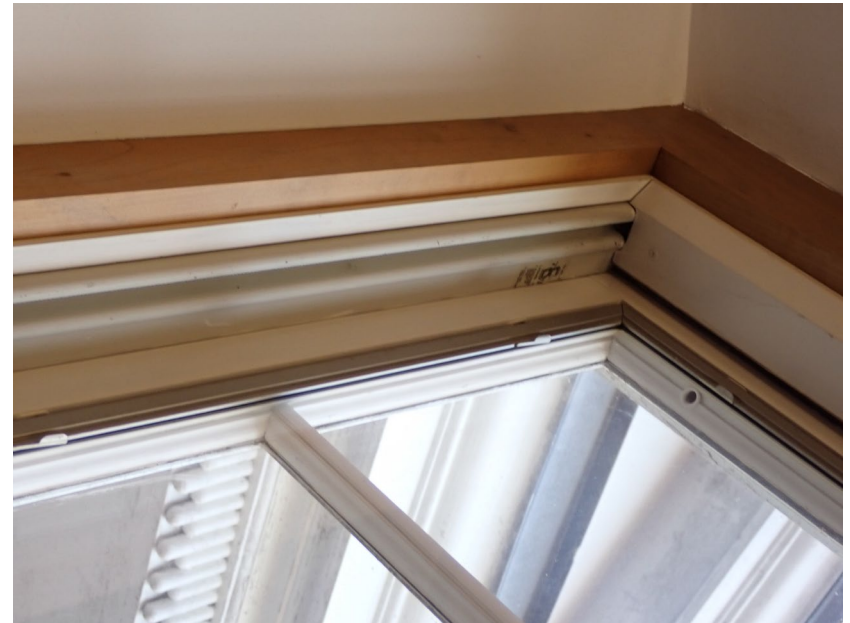
16. Basement level, north wall, detail of typical 1993 double-hung wood window condition

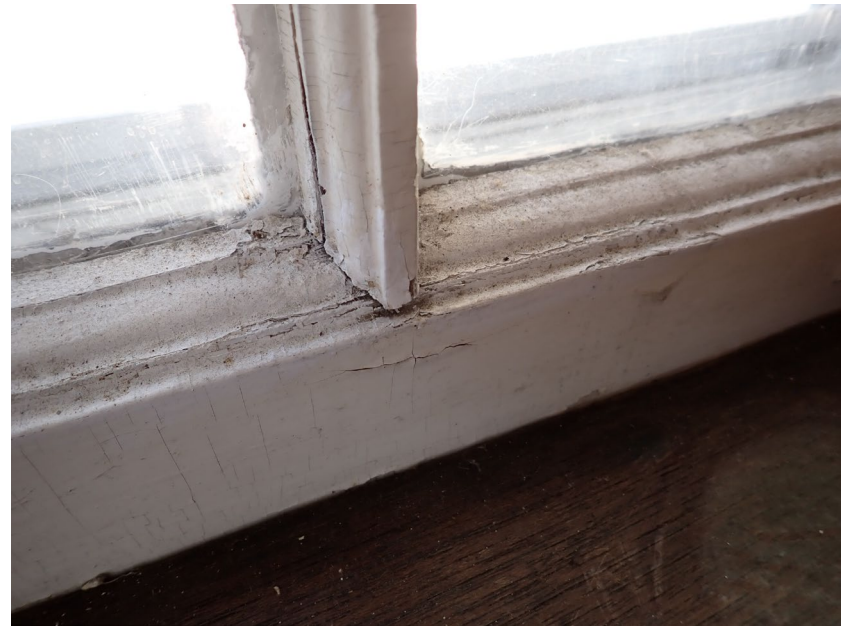
18. First floor, south wall, detail of typical historic wood window deterioration

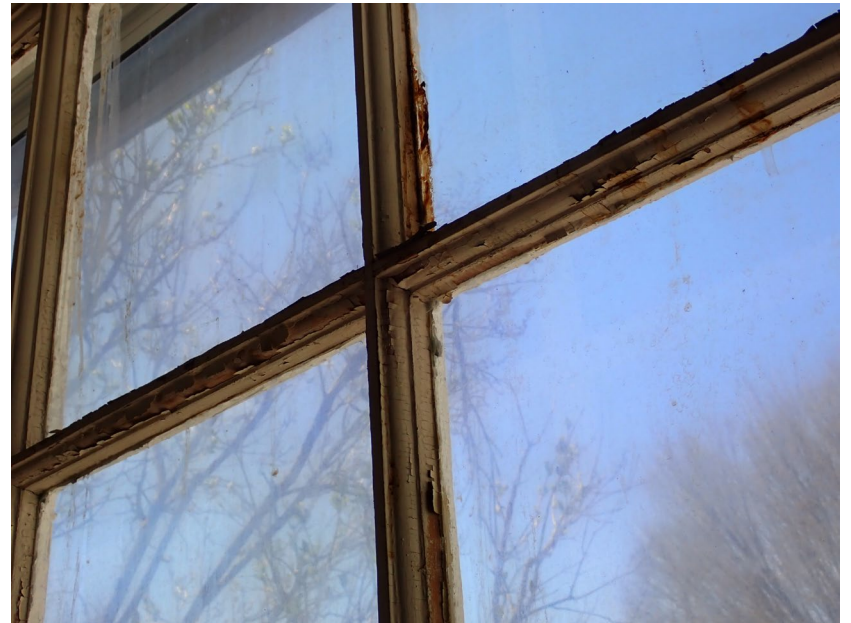
20. First floor, south wall, detail of typical historic wood window deterioration

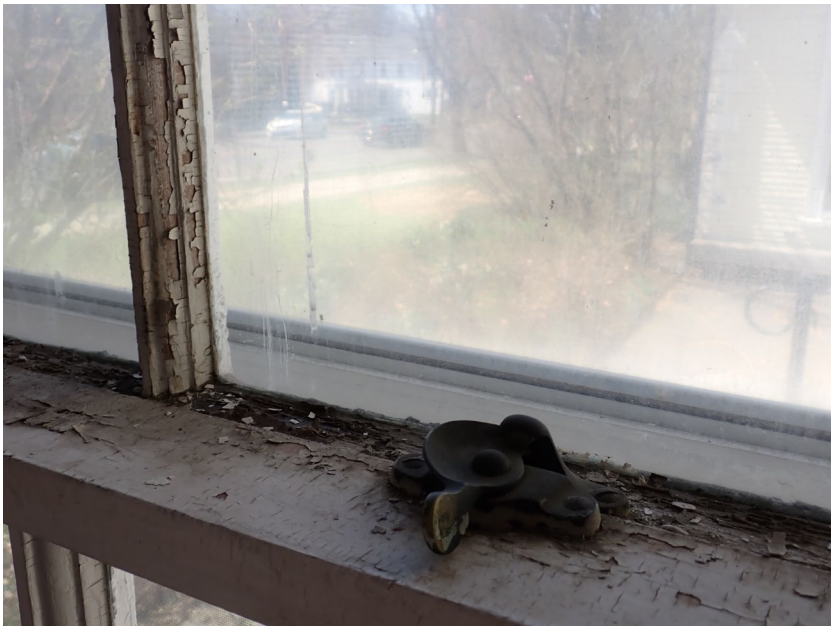
21. First floor, south wall, detail of typical historic wood window deterioration

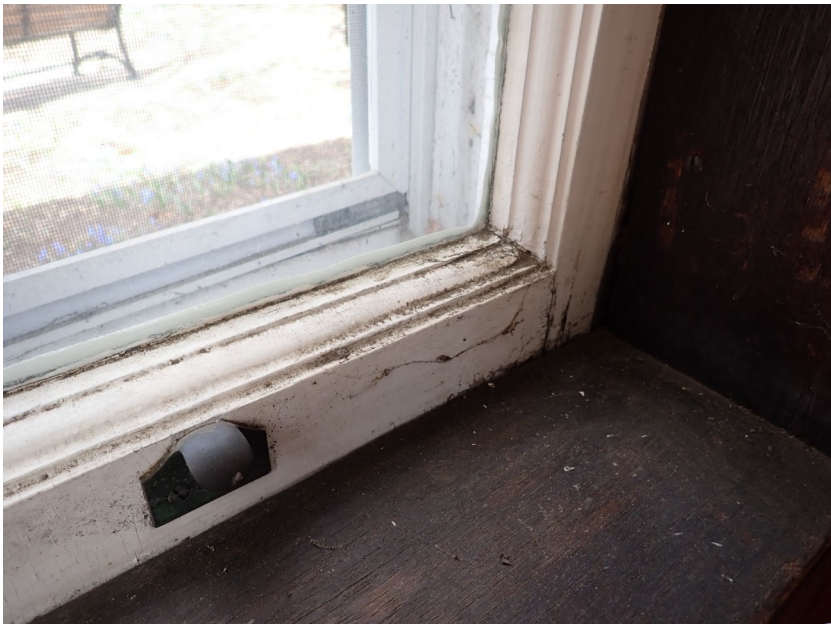
23. First floor, west wall, detail of typical historic wood window deterioration

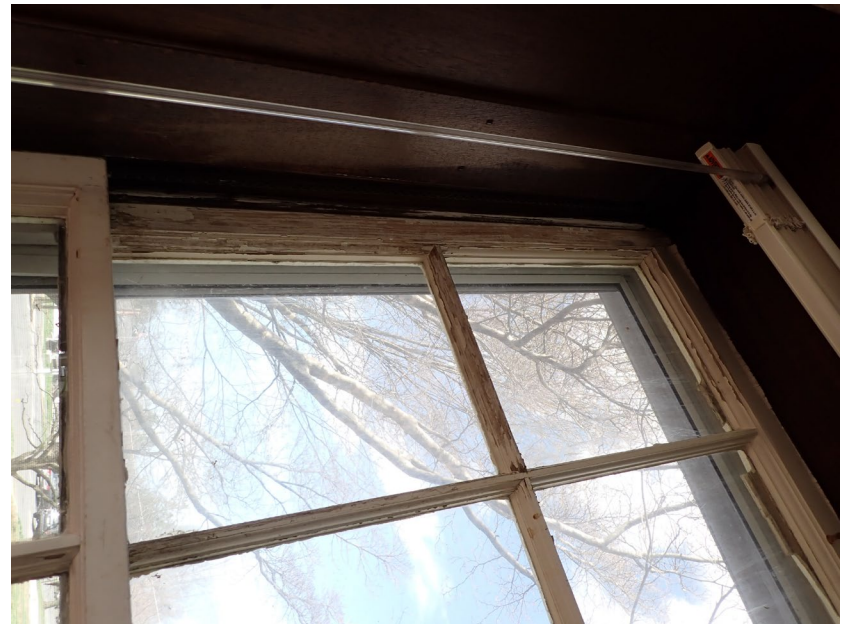
24. First floor, west wall, detail of typical historic wood window deterioration

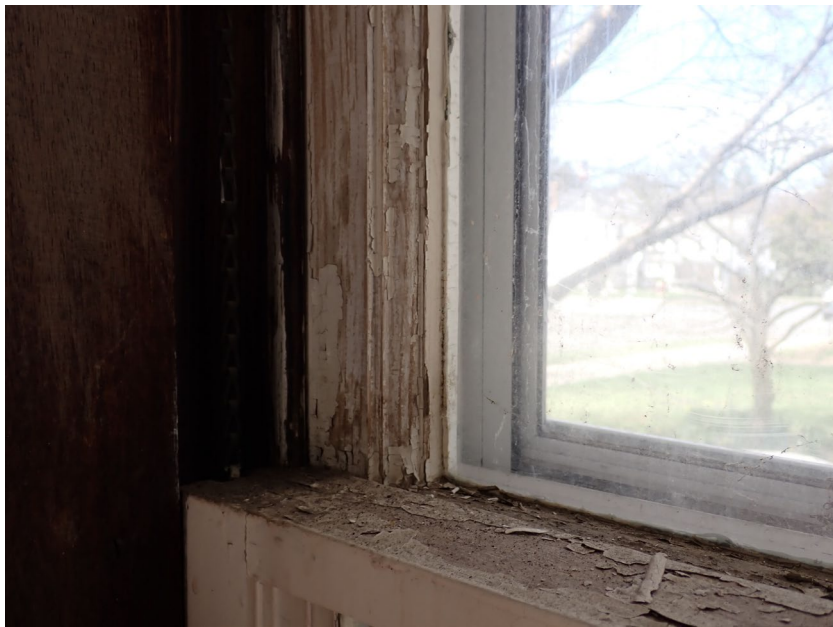
25. First floor, west wall, detail of typical historic wood window deterioration

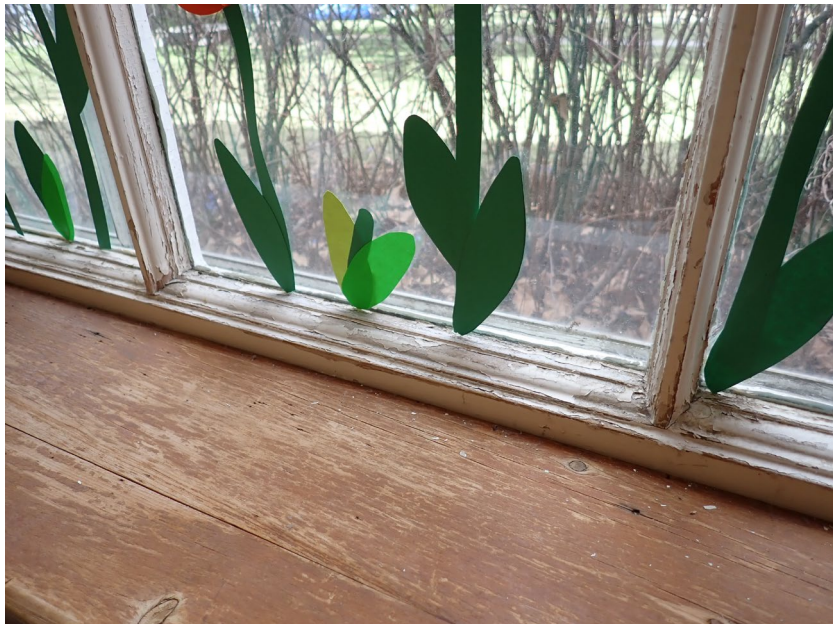
27. First floor, west wall, detail of typical historic wood window deterioration

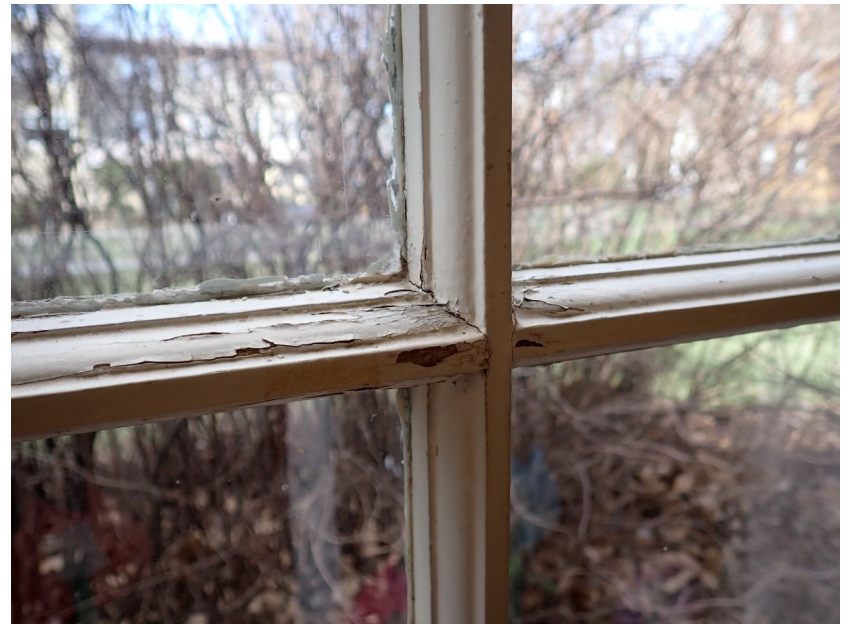
28. First floor, west wall, detail of typical historic wood window deterioration

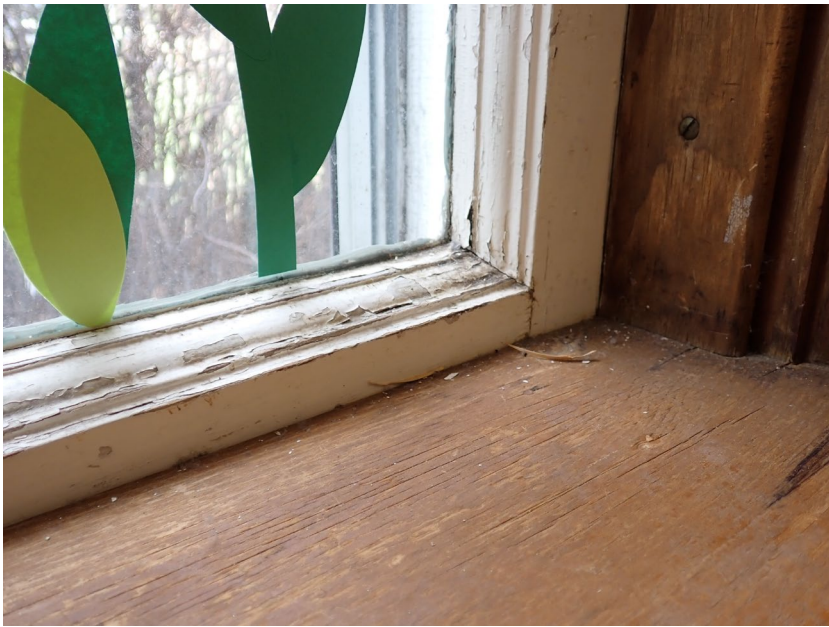
29. First floor, west wall, detail of typical historic wood window deterioration

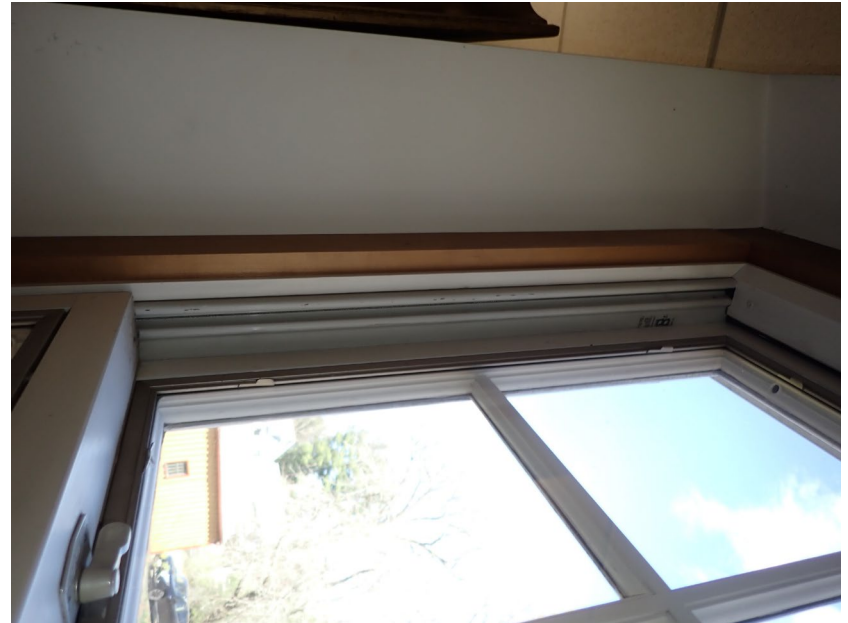
32. First floor, north wall, detail of typical 1993 wood window condition

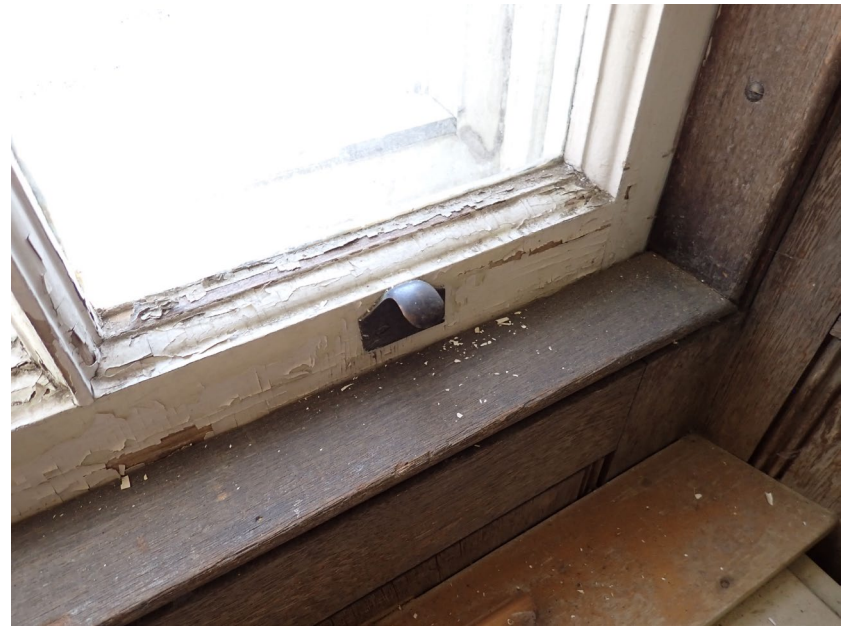
34. First floor, east wall, detail of typical historic wood window deterioration

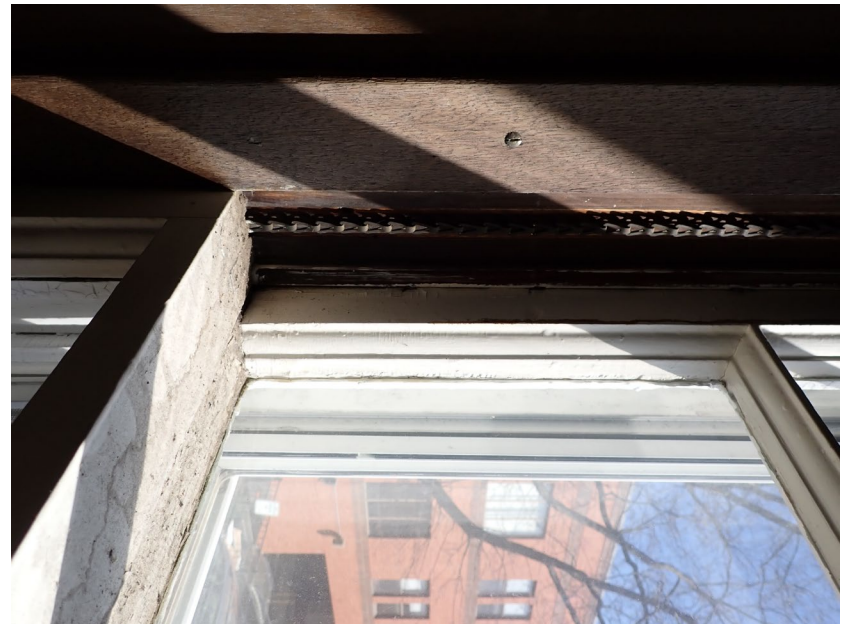
36. First floor, east wall, detail of typical historic wood window deterioration

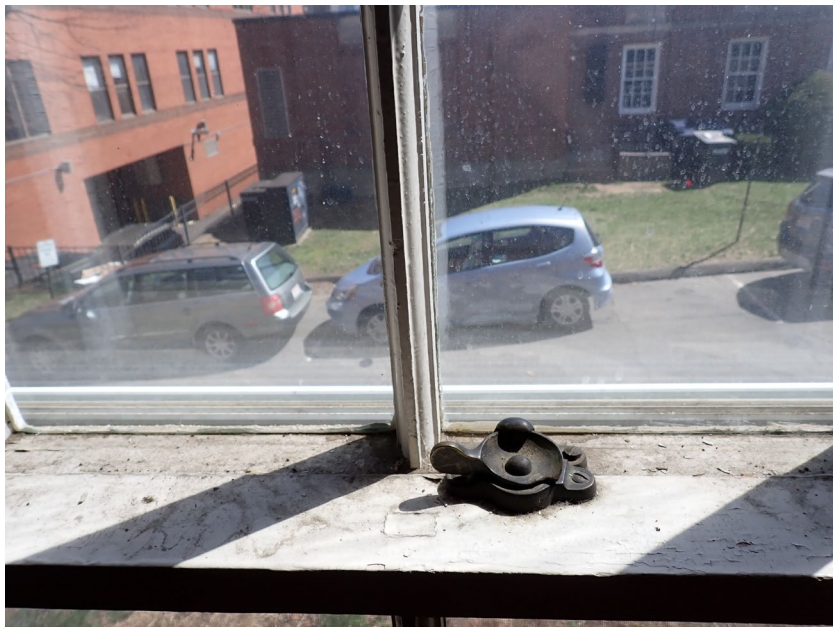
37. First floor, east wall, detail of typical historic wood window deterioration

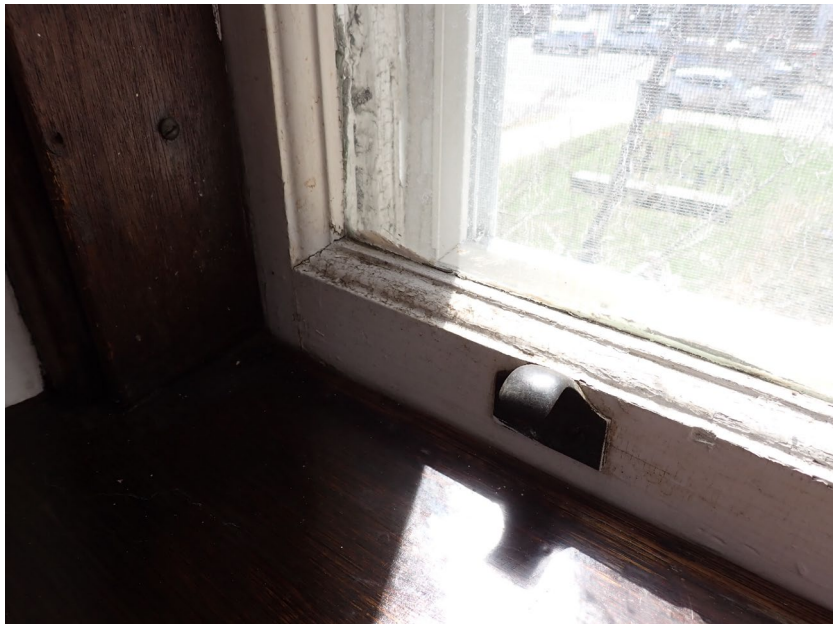
39. Second floor, south wall, detail of typical historic wood window deterioration

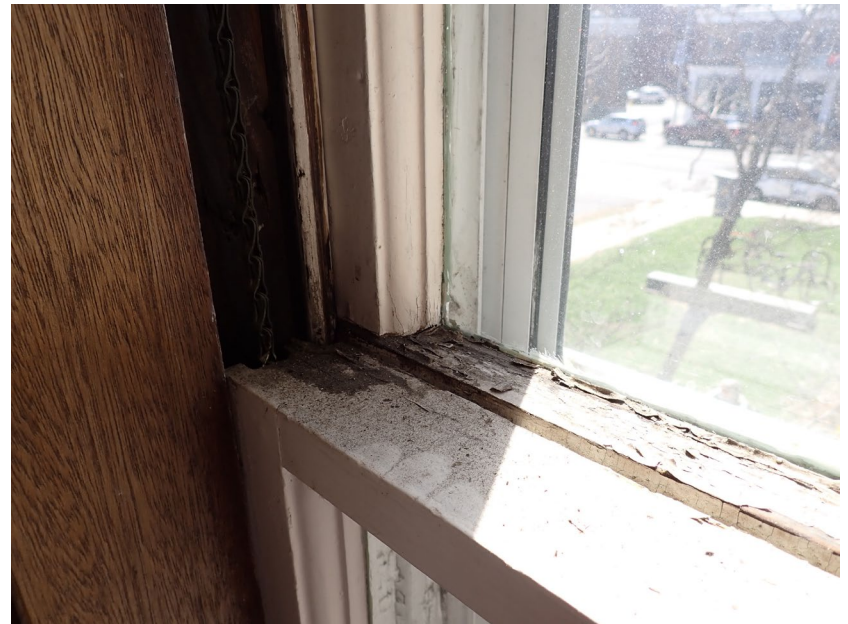
40. Second floor, south wall, detail of typical historic wood window deterioration

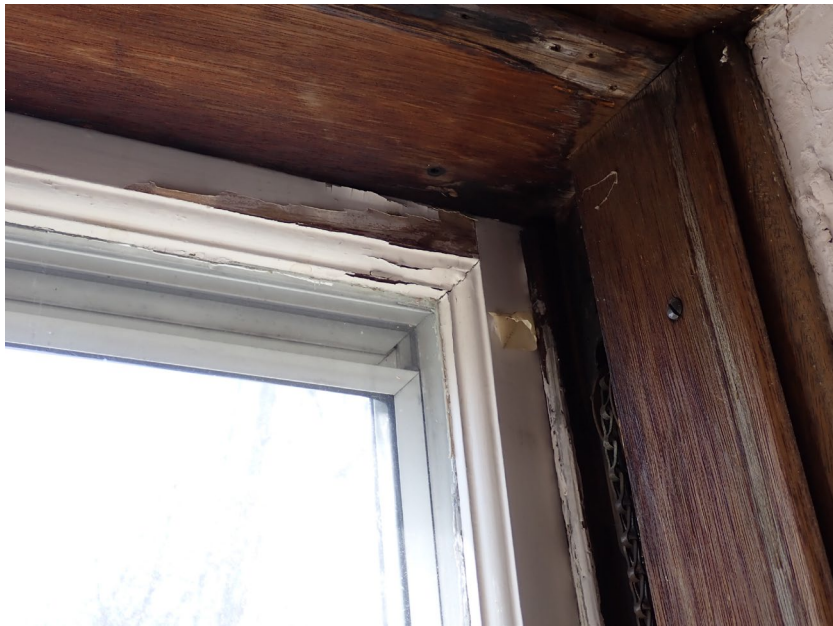
41. Second floor, south wall, detail of typical historic wood window deterioration

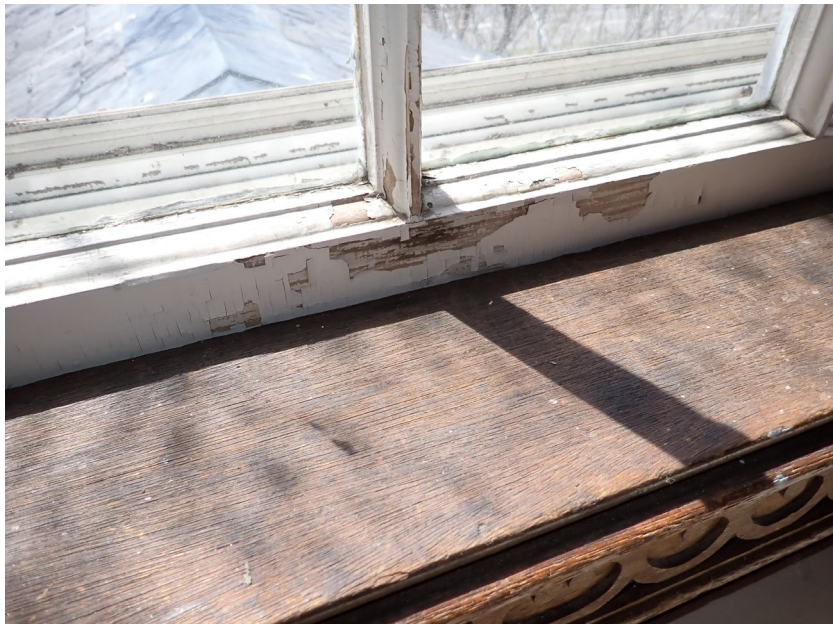
43. Second floor, south wall, detail of typical historic wood window deterioration

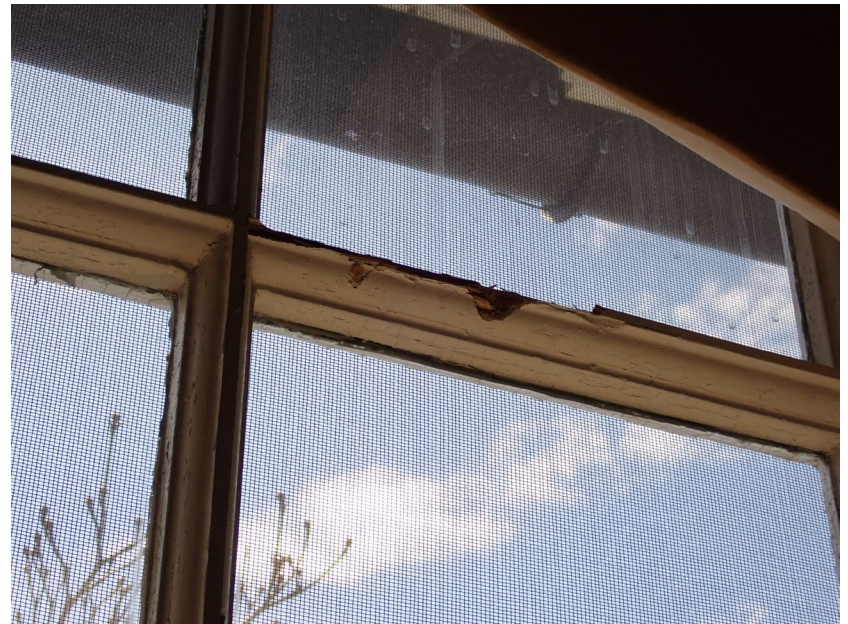
44. Second floor, south wall, detail of typical historic wood window deterioration

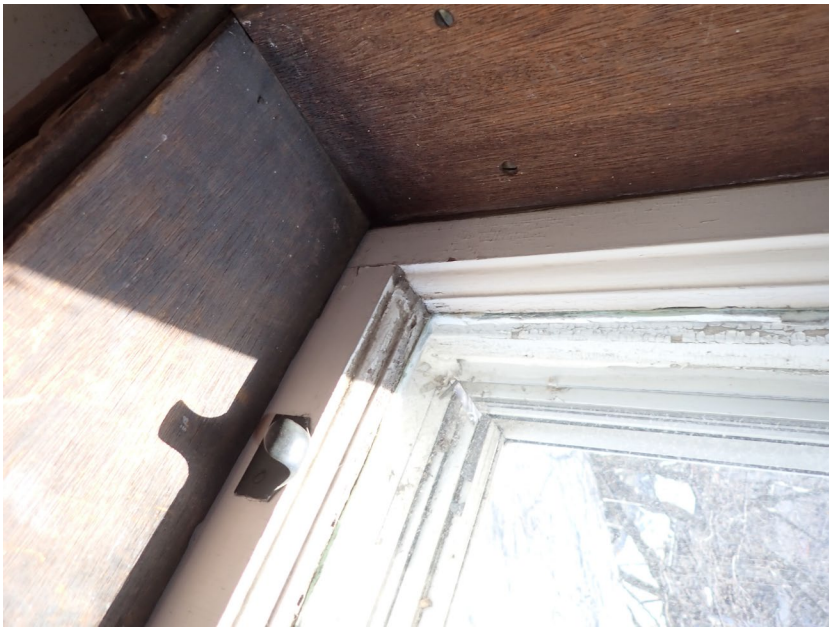
45. Second floor, south wall, detail of typical historic wood window deterioration

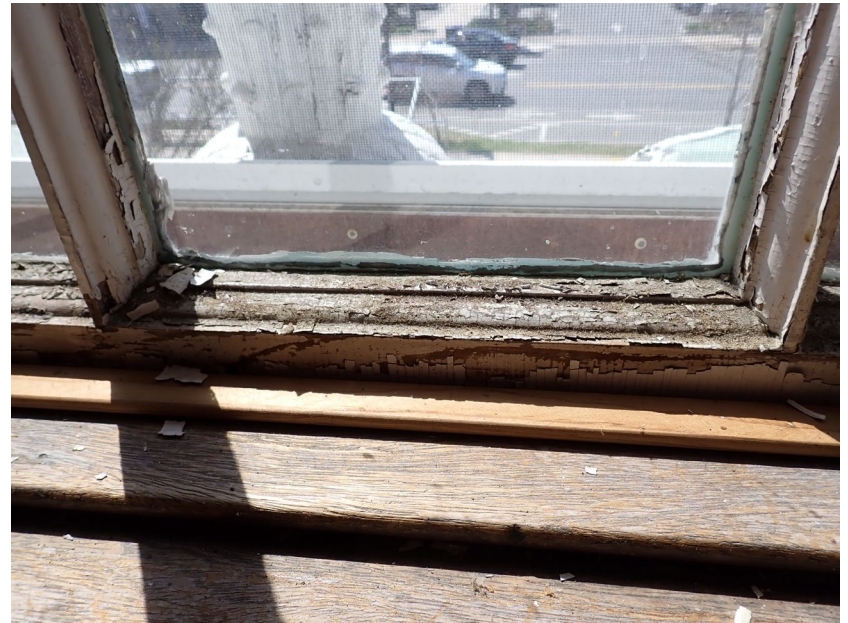
48. Second floor, south wall, detail of typical historic wood window deterioration

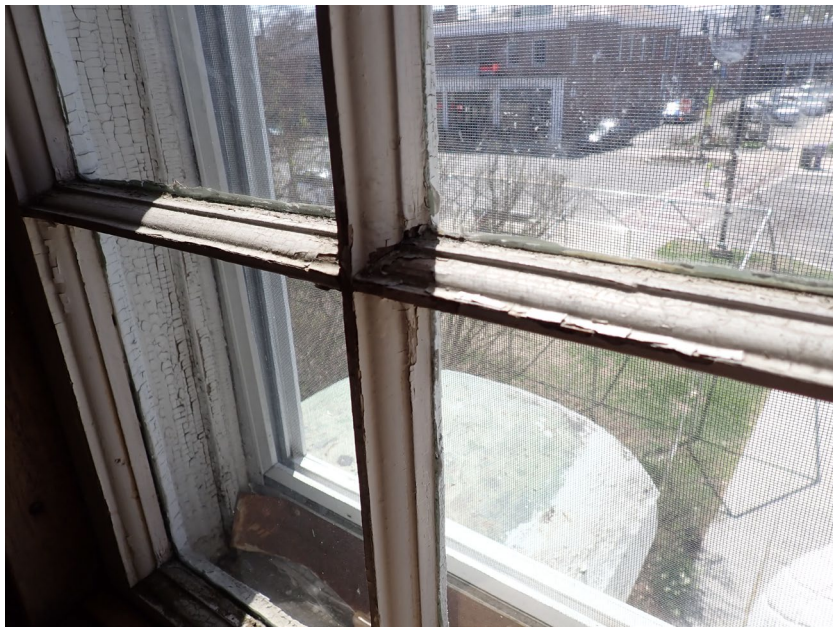
49. Second floor, south wall, detail of typical historic wood window deterioration

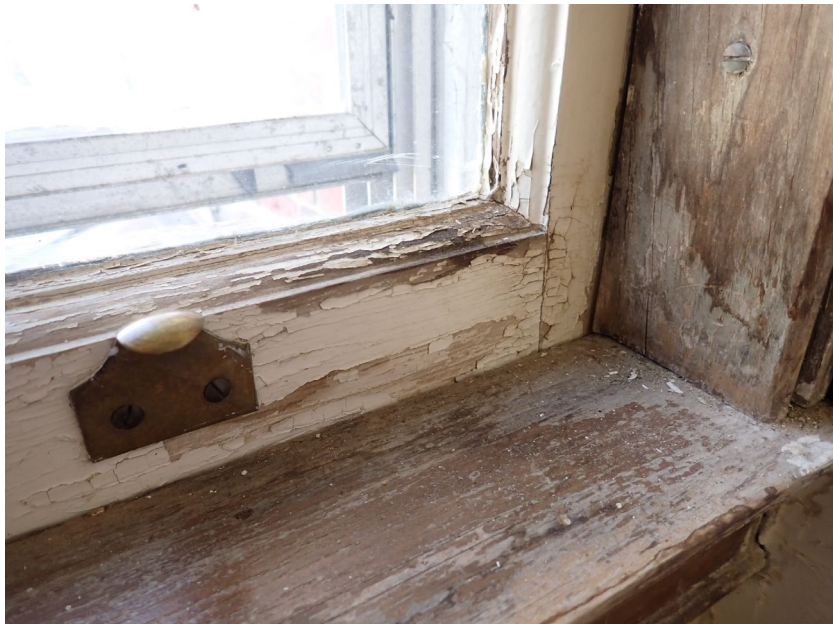
51. Second floor, west wall, detail of typical historic wood window deterioration

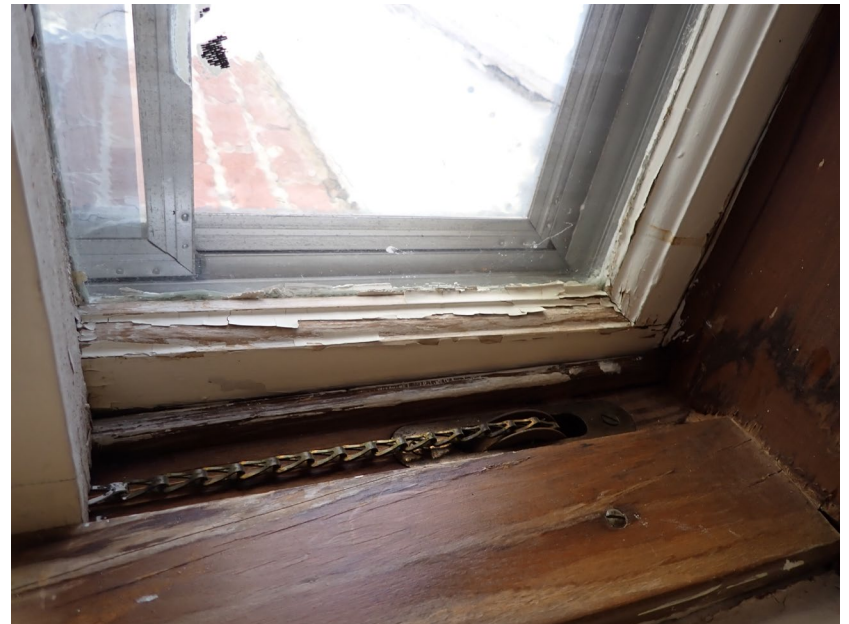
52. Second floor, west wall, detail of typical historic wood window deterioration

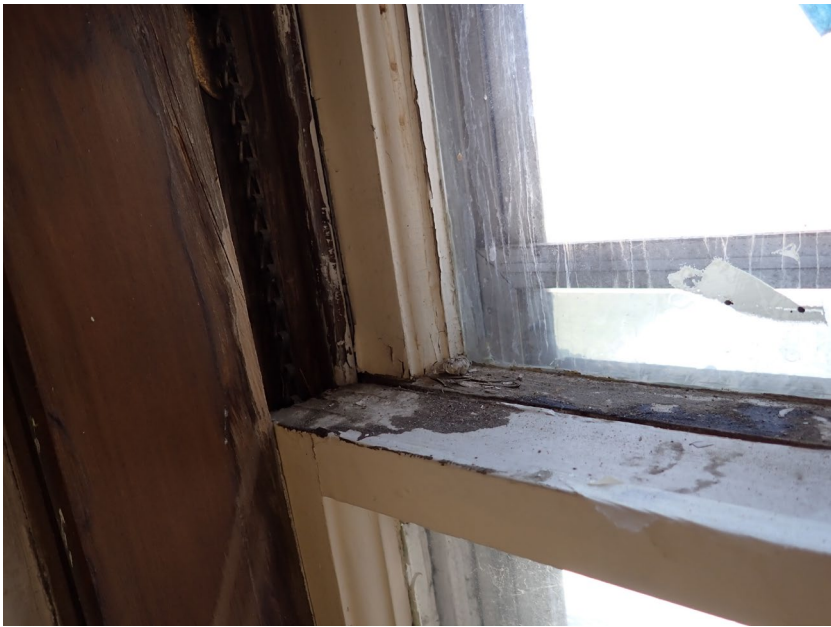
53. Second floor, west wall, detail of typical historic wood window deterioration

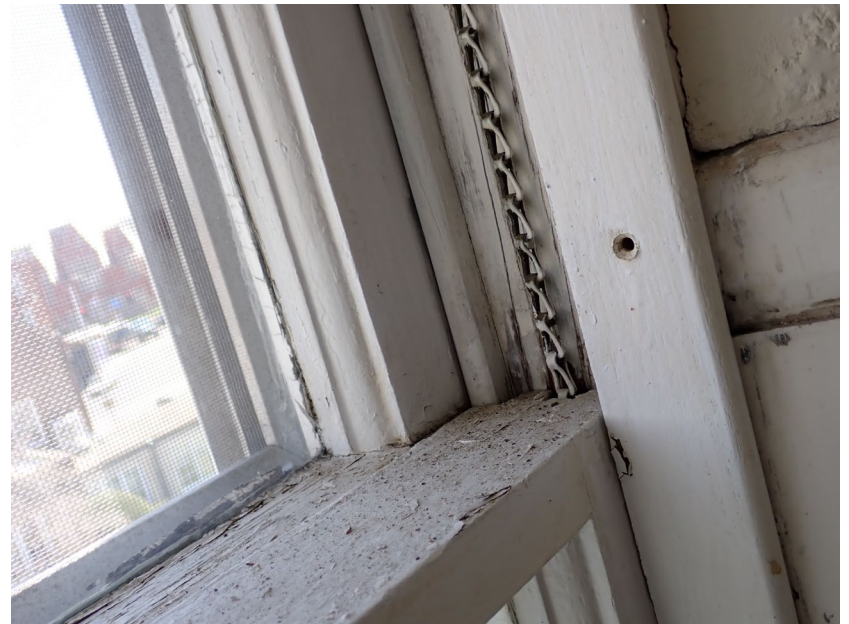
56. Third floor, east wall, detail of typical historic wood window deterioration

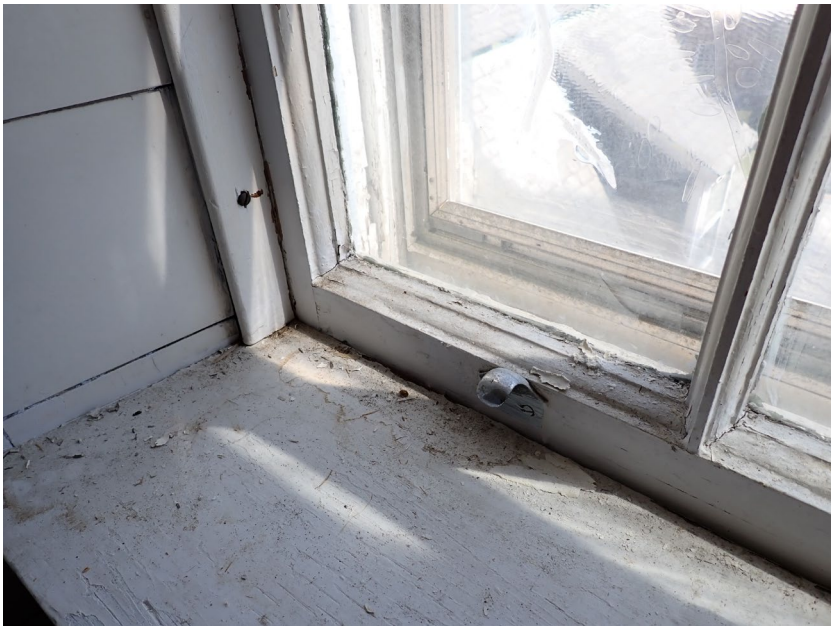
57. Third floor, east wall, detail of typical historic wood window deterioration

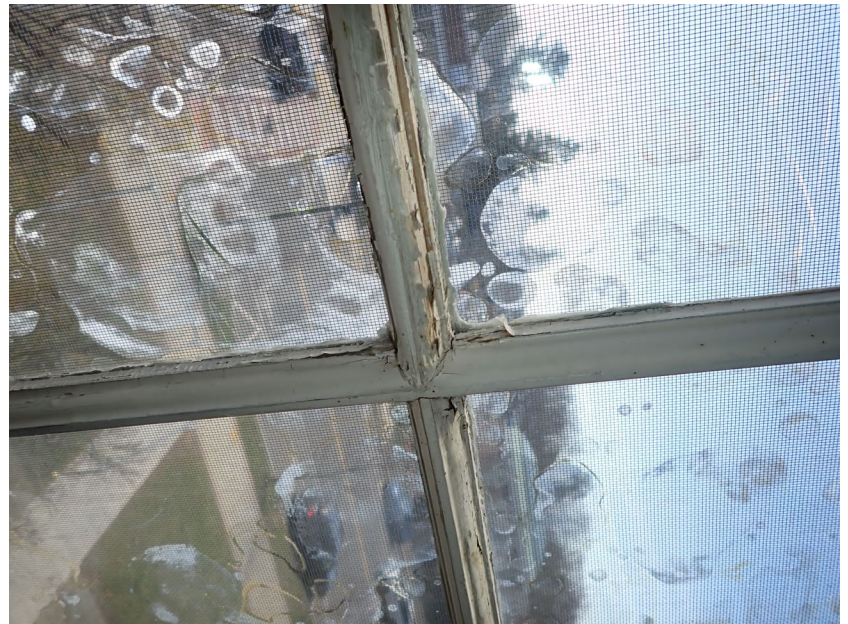
60. Third floor, south wall, detail of typical historic wood window deterioration

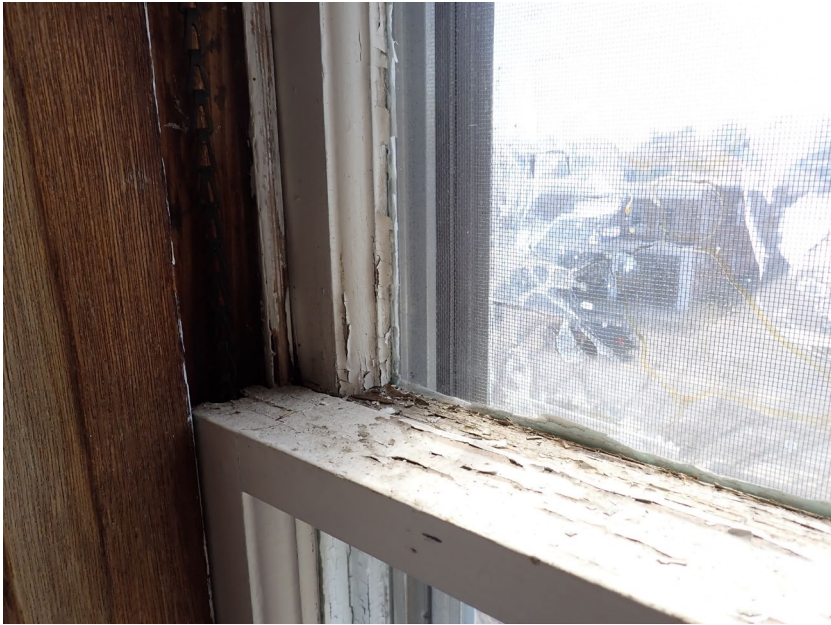
61. Third floor, south wall, detail of typical historic wood window deterioration

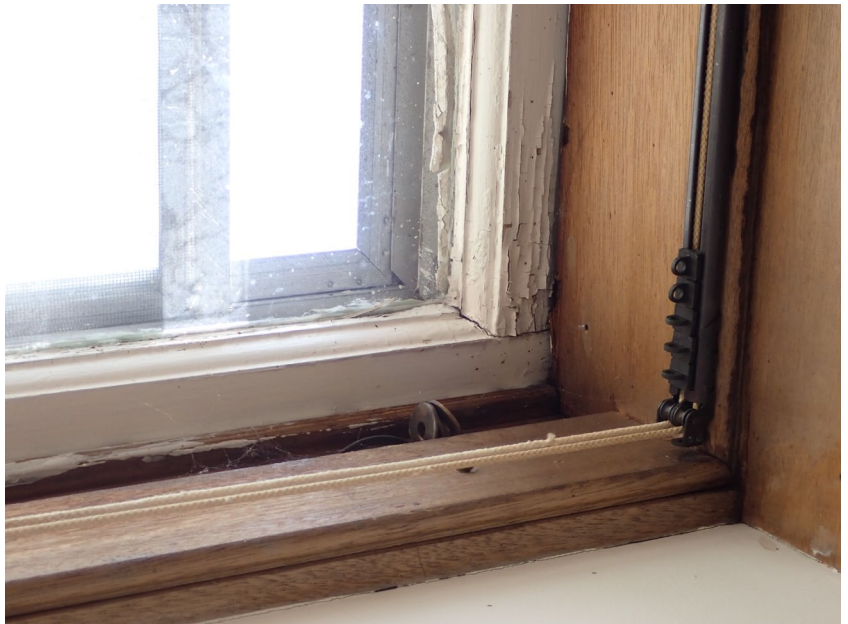
64. Third floor, south wall, detail of typical historic wood window deterioration

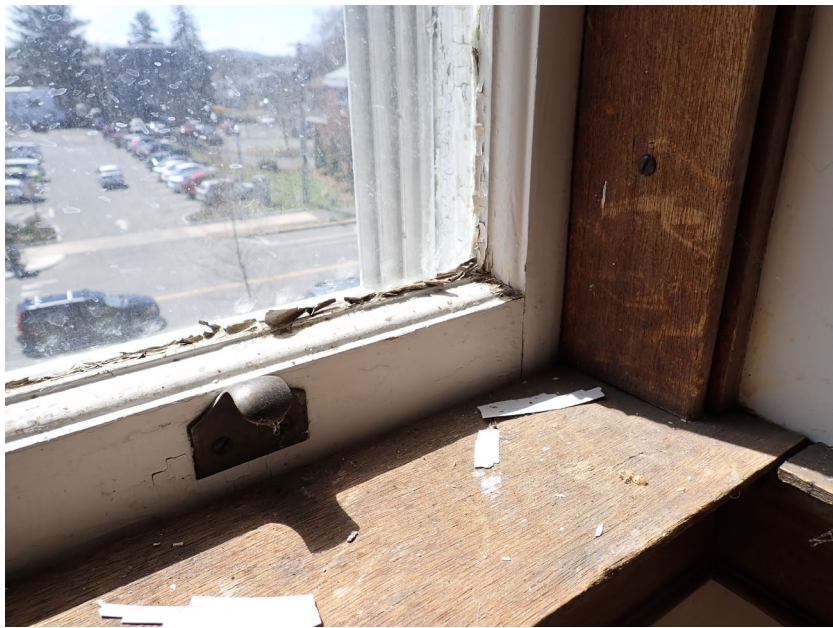
65. Third floor, south wall, detail of typical historic wood window deterioration
