**Subject: Jones Library, 43 Amity Street, Amherst, MA
Massachusetts Historic Rehabilitation Tax Credit Application**

Massachusetts Historic Rehabilitation
Tax Credit Application, Parts 1 & 2

Jones Library

43 Amity Street, Amherst

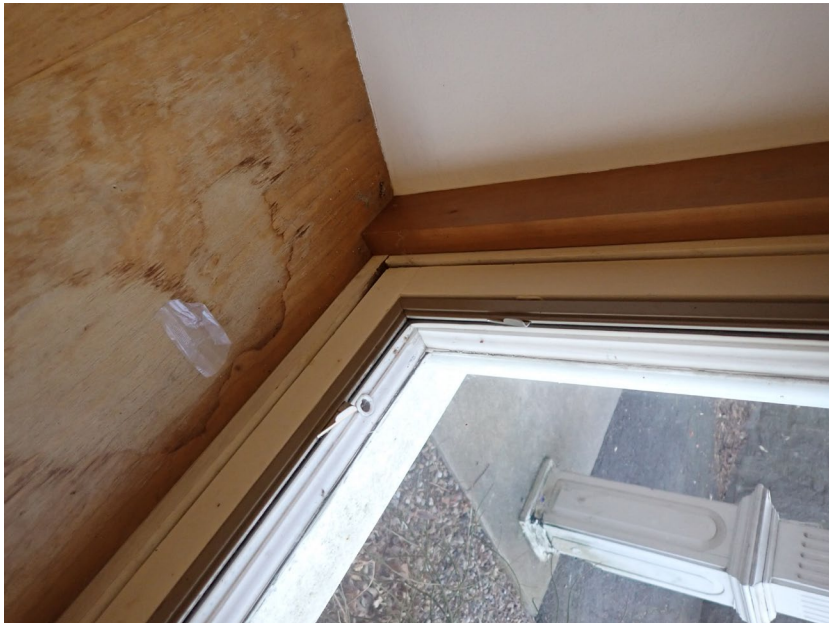
15. Basement level, north wall, detail of typical 1993 double-hung wood window condition

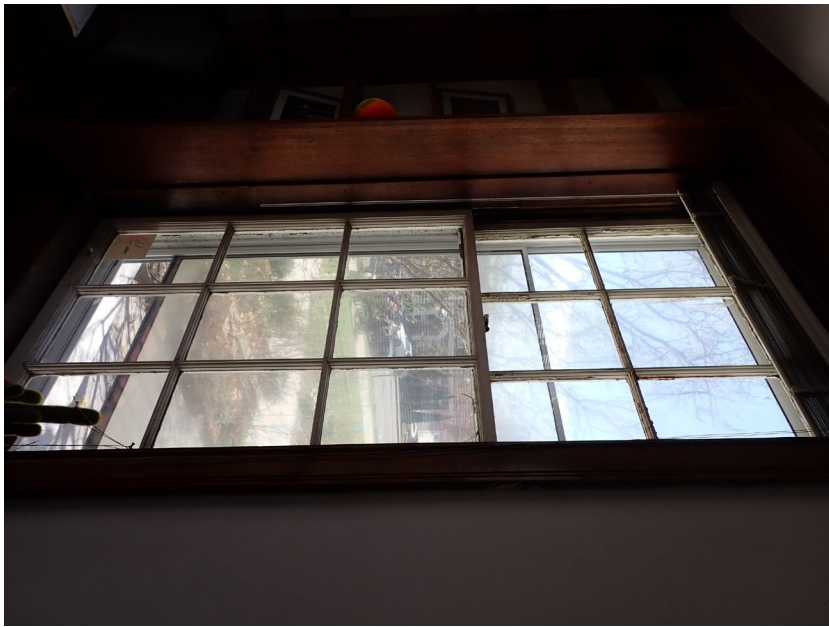
17. First floor, south wall, typical historic double-hung wood window

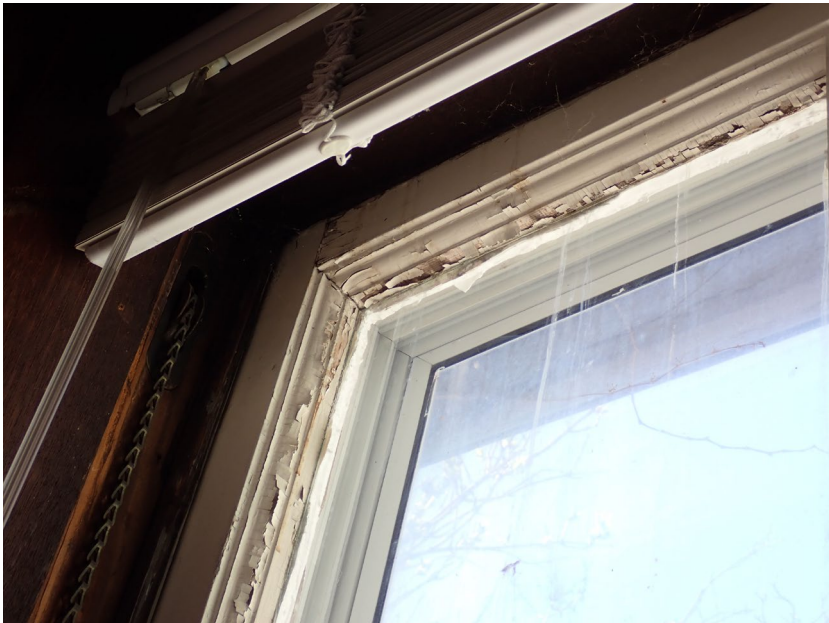
19. First floor, south wall, detail of typical historic wood window deterioration

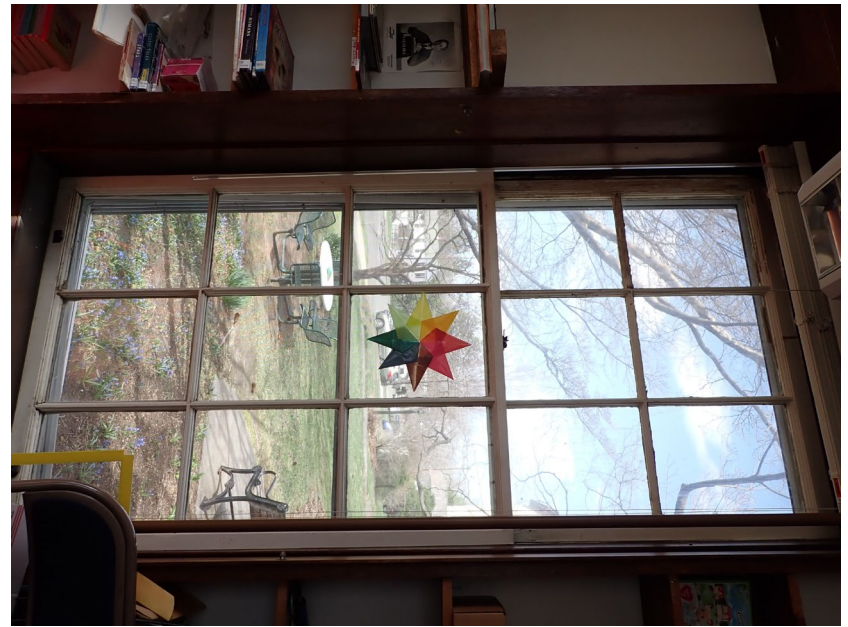
22. First floor, west wall, typical historic double-hung wood window

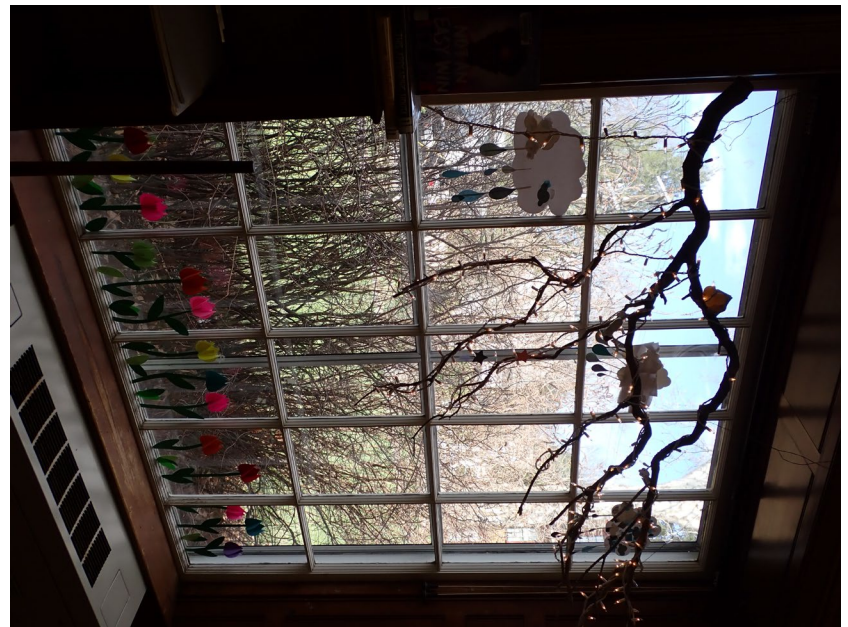
26. First floor, west wall, typical fixed wood window

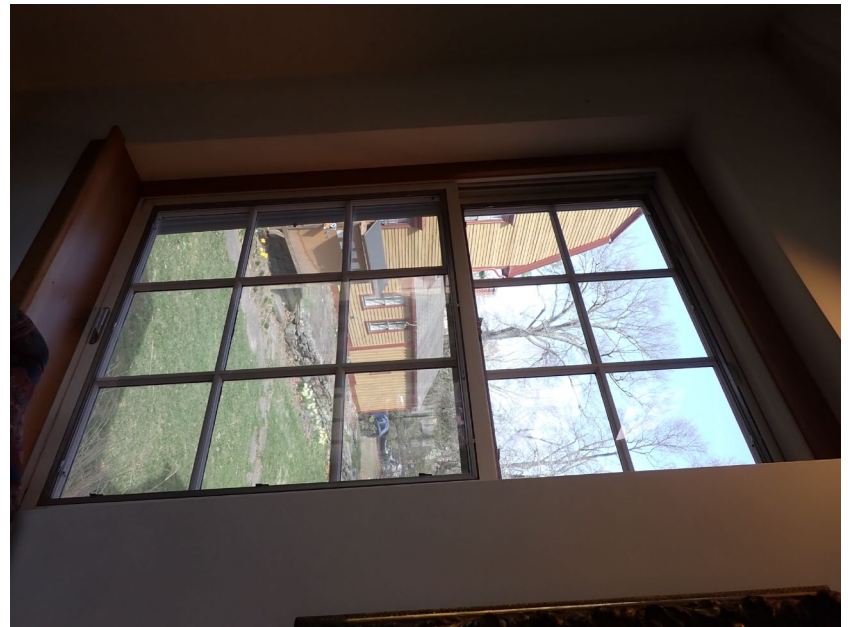
30. First floor, north wall, typical double-hung wood window at 1993 addition

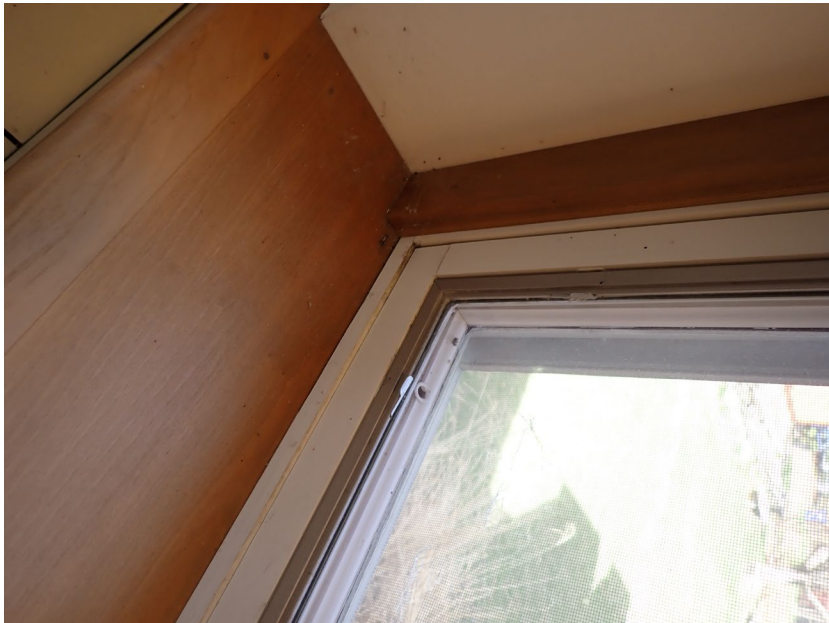
31. First floor, north wall, detail of typical 1993 wood window condition

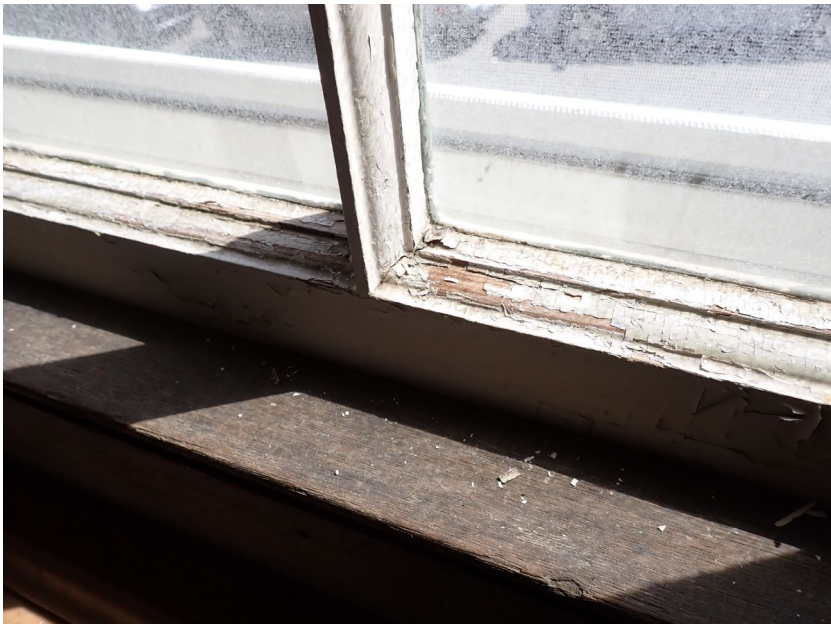
35. First floor, east wall, detail of typical historic wood window deterioration

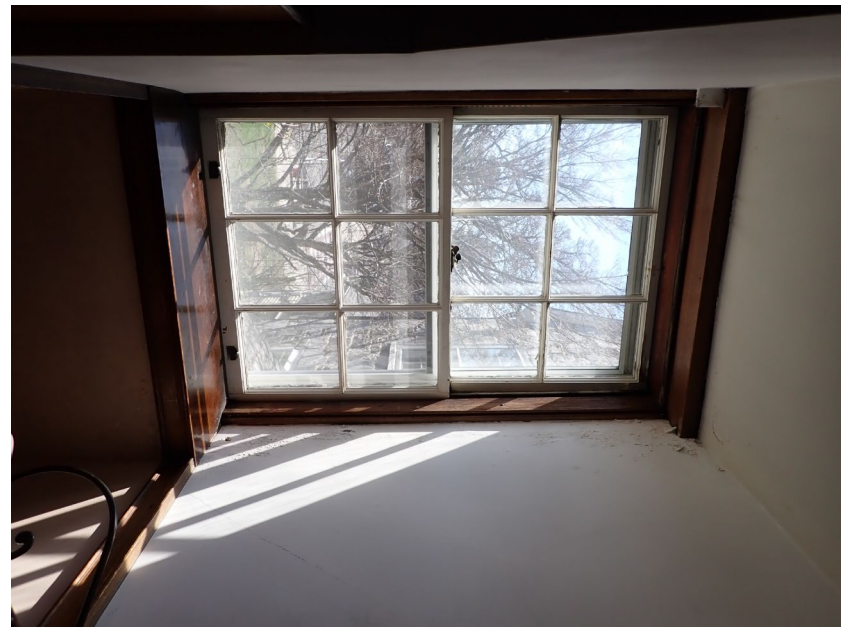
38. Second floor, south wall, typical historic double-hung wood dormer window

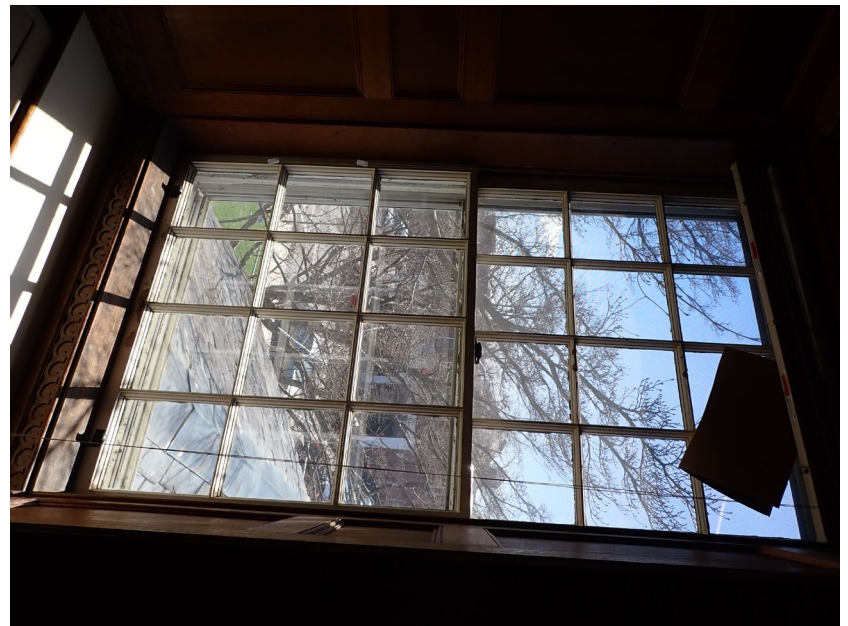
42. Second floor, south wall, typical historic double-hung wood window

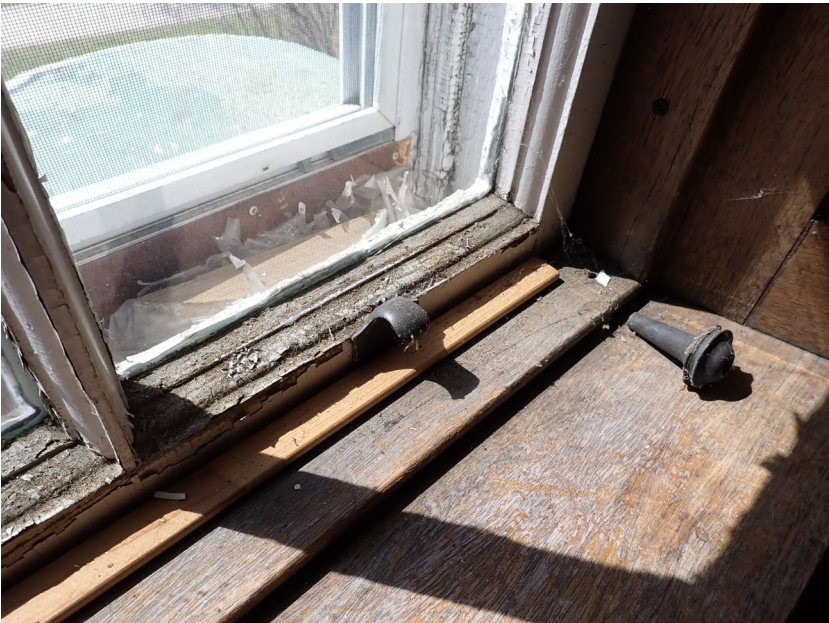
47. Second floor, south wall, detail of typical historic wood window deterioration

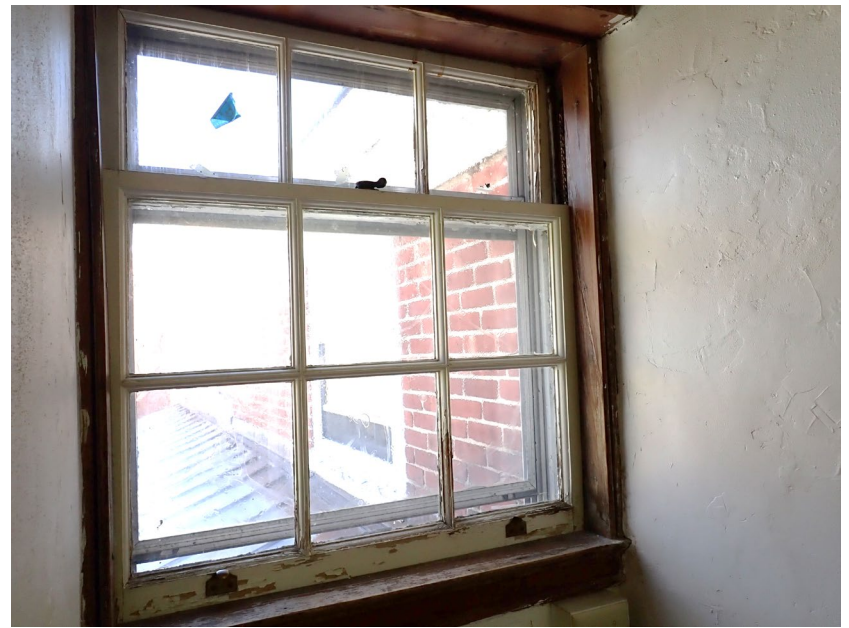
50. Second floor, west wall, typical historic double-hung wood window

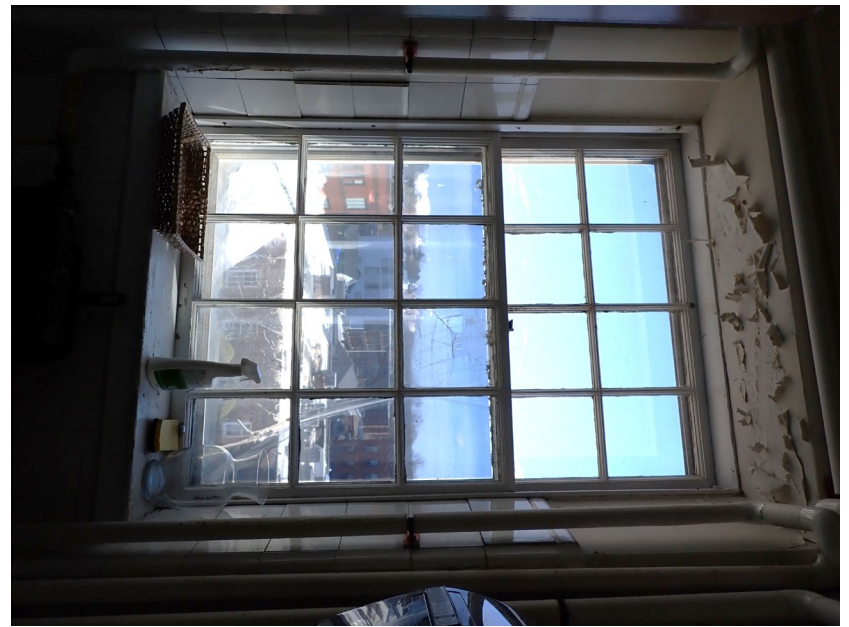
54. Third floor, east wall, typical historic double-hung wood window

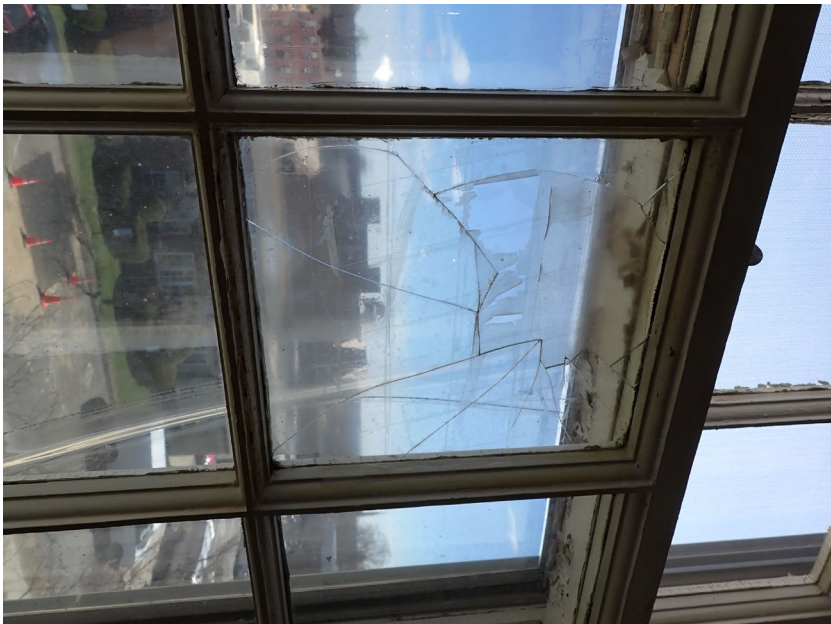
55. Third floor, east wall, detail of typical historic wood window deterioration

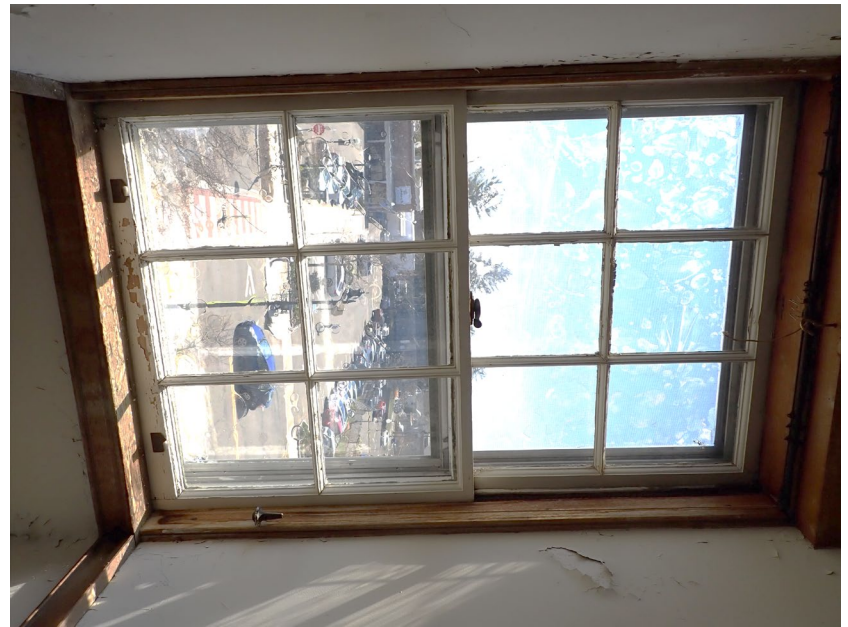
58. Third floor, south wall, typical historic double-hung wood window

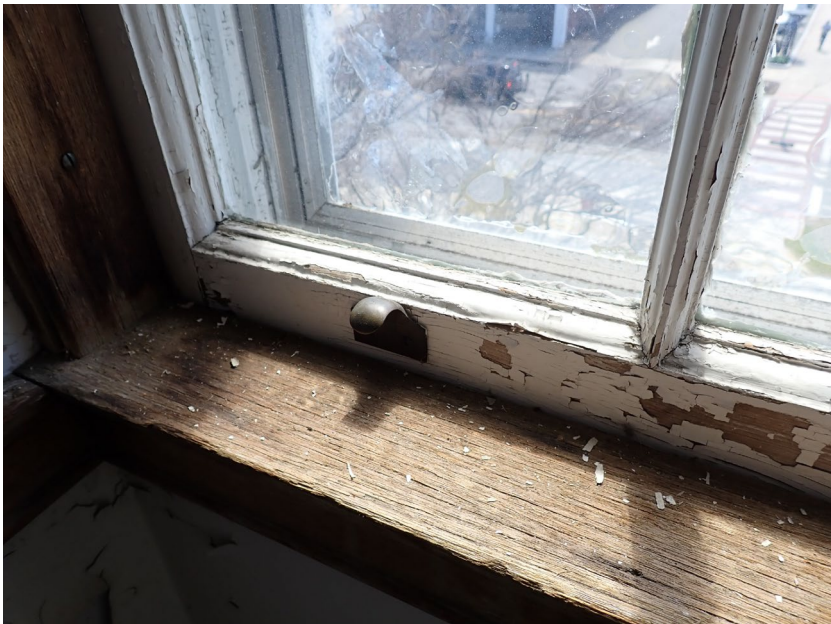
59. Third floor, south wall, detail of typical historic wood window deterioration

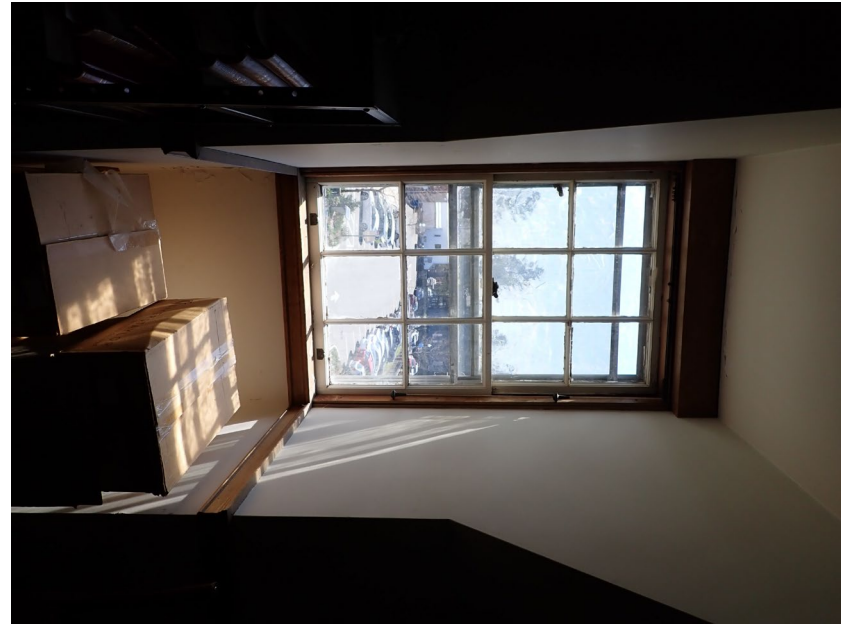
62. Third floor, south wall, typical historic double-hung wood window

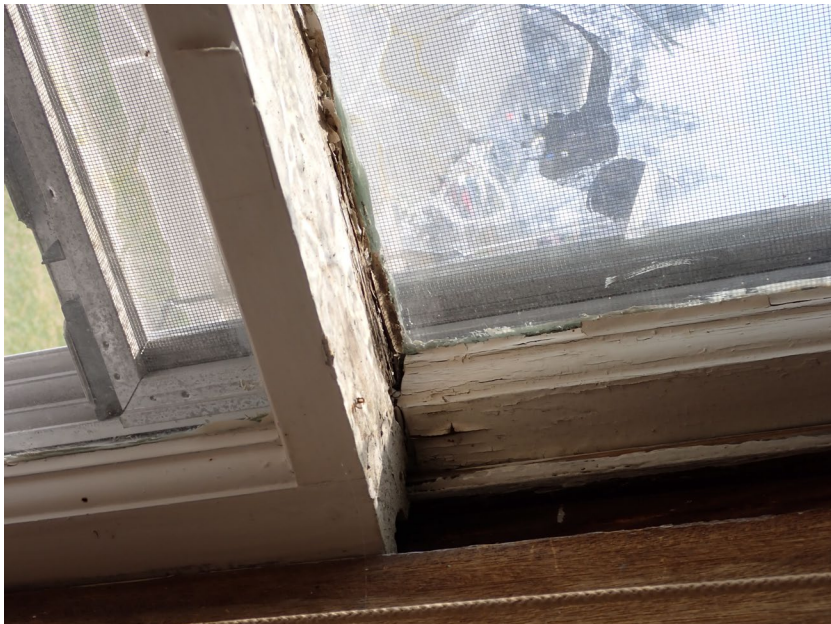
63. Third floor, south wall, detail of typical historic wood window deterioration
